**Flood Control Project Maintenance
Levee Inspections**

Maintenance Issue Types Only, Levee Inspection Report By Mile - Spring 2019

Reclamation District No. 0001 Union Island

Waterway	Bank	Unit Miles	Inspection Start/End	Inspector
Unit No. 01 Old River	Right	1.14	04/04/2019 04/04/2019	Alberto De Leon

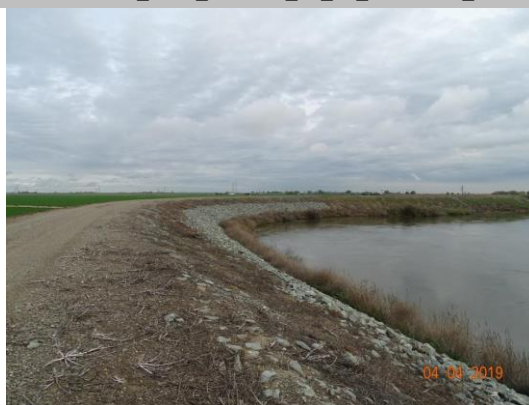
Photo 1 of 1 : SP_2019_RD0001_23_20_20190415_00026.jpg

LM Start	0.00	Rating **	A	Issue No.	20	
LM End	1.14	Issue Type +	Ma	Location *	WS	
Category	Earthen Levee			GPS Latitude/Longitude		
				Start		End
Item	Vegetation			37.822585 °		37.811714 °
				-121.375532 °		-121.384876 °
DWR ID	DWR_RD0001_01_f_2018_20					
Comment Code						
V1 : Control annual grass and weeds on the levee slopes and easements.						
Inspector Comment						
The annual vegetation is well maintained.

View looking upstream waterside at the well maintained annual vegetation, Spring 2019.

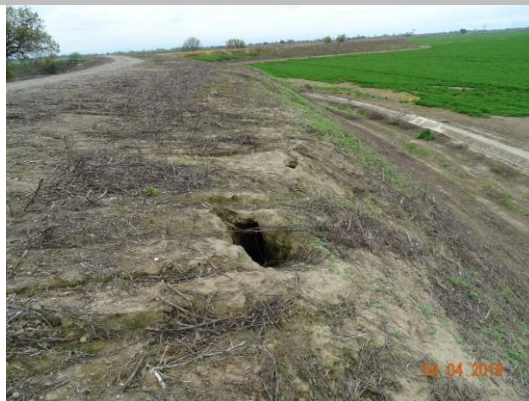
Photo 1 of 1 : SP_2019_RD0001_23_23_20190415_00027.jpg

LM Start	0.15	Rating **	U	Issue No.	23
LM End	0.15	Issue Type +	Ma	Location *	LS
Category	Earthen Levee			GPS Latitude/Longitude	
				Start	End
Item	Animal Control			37.821610 °	37.821610 °
				-121.377962 °	-121.377962 °
DWR ID	DWR_RD0001_01_s_2019_23				
Comment Code					
A3 : No rodents visible, but rodent burrows visible; need to backfill and compact or grout burrows.					
Inspector Comment					
A large rodent hole is located on the landside shoulder. It is approximately 3 ft. x 2 ft. and needs to be repaired. (Spring 2019)

View looking landside at large rodent hole on levee slope, Spring 2019.

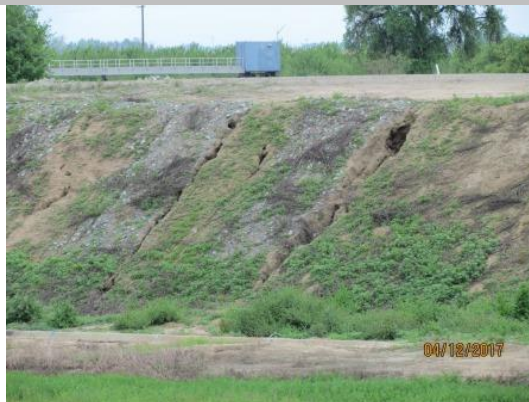
Photo 1 of 1 : SP_2019_RD0001_23_18_20190313_00016.jpg

LM Start	0.21	Rating **	M	Issue No.	18
LM End	0.21	Issue Type +	Ma	Location *	LS
Category	Earthen Levee			GPS Latitude/Longitude	
				Start	End
Item	Erosion / Bank Caving			37.820806 °	37.820806 °
				-121.378260 °	-121.378260 °
DWR ID	DWR_RD0001_01_s_2017_18				
Comment Code					
E2 : Schedule repair of erosion site prior to the next inspection.					
Inspector Comment

View of the erosion on the levee slope.

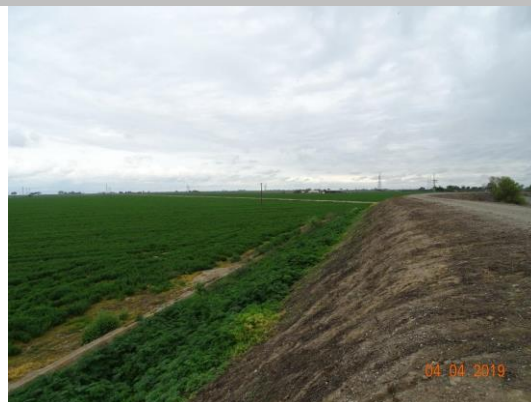
Photo 1 of 1 : SP_2019_RD0001_23_22_20190415_00029.jpg

LM Start	0.42	Rating **	M	Issue No.	22
LM End	0.48	Issue Type +	Ma	Location *	LS
Category	Earthen Levee			GPS Latitude/Longitude	
				Start	End
Item	Vegetation			37.819162 °	37.818412 °
				-121.380438 °	-121.379993 °
DWR ID	DWR_RD0001_01_s_2019_22				
Comment Code					
V2 : Remove the wild growth other than native grasses from the levee slopes.					
Inspector Comment					
There is heavy vegetation between the landside toe and the concerte ditch which needs to be removed. Spring 2019

View of landside levee toe with heavy vegetation parallel to concrete lined ditch, spring 2019.

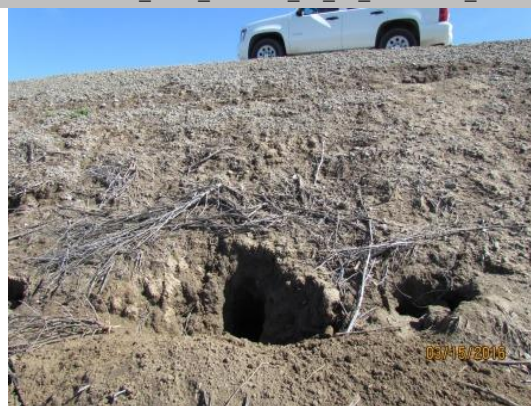
Photo 1 of 1 : SP_2019_RD0001_23_14_20190313_00012.jpg

LM Start	0.44	Rating **	U	Issue No.	14
LM End	0.44	Issue Type +	Ma	Location *	LS
Category	Earthen Levee			GPS Latitude/Longitude	
				Start	End
Item	Animal Control			37.818898 °	37.818898 °
				-121.380332 °	-121.380332 °
DWR ID	DWR_RD0001_01_s_2016_14				
Comment Code					
A1 : Exterminate rodents and backfill and compact or grout burrows.					
Inspector Comment					
There is an active rodent den the size of a coyote or fox.

View of the large rodent hole on the landside levee slope.

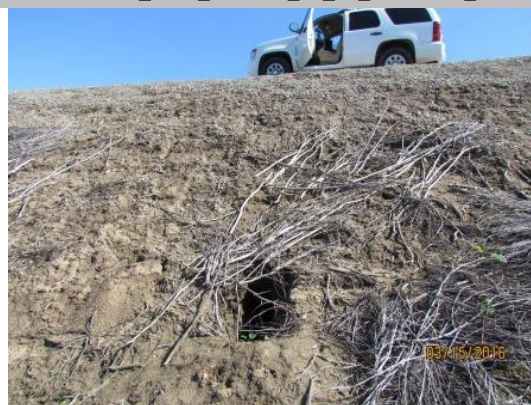
Photo 1 of 1 : SP_2019_RD0001_23_10_20190313_00006.jpg

LM Start	0.45	Rating **	U	Issue No.	10
LM End	0.45	Issue Type +	Ma	Location *	LS
Category	Earthen Levee			GPS Latitude/Longitude	
				Start	End
Item	Animal Control			37.818753 °	37.818753 °
				-121.380249 °	-121.380249 °
DWR ID	DWR_RD0001_01_s_2016_10				
Comment Code					
A3 : No rodents visible, but rodent burrows visible; need to backfill and compact or grout burrows.					
Inspector Comment					
Backfill the rodent hole and compact levee slope with acceptable levee fill.

View of the large rodent hole on the landside levee slope.

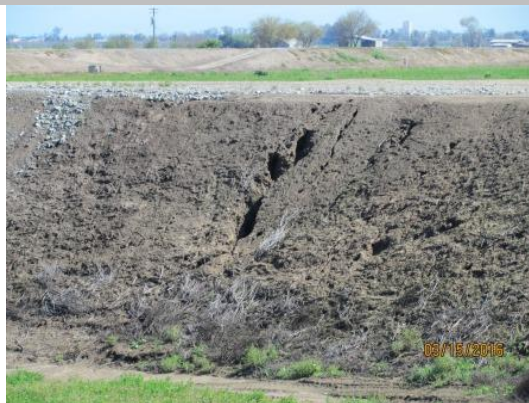
Photo 1 of 1 : SP_2019_RD0001_23_7_20190313_00005.jpg

LM Start	0.52	Rating **	M	Issue No.	7
LM End	0.52	Issue Type +	Ma	Location *	LS
Category	Earthen Levee			GPS Latitude/Longitude	
				Start	End
Item	Erosion / Bank Caving			37.817825 °	37.817825 °
				-121.379811 °	-121.379811 °
DWR ID	DWR_RD0001_01_s_2016_7				
Comment Code					
E2 : Schedule repair of erosion site prior to the next inspection.					
Inspector Comment

View of the erosion on the landside levee slope.

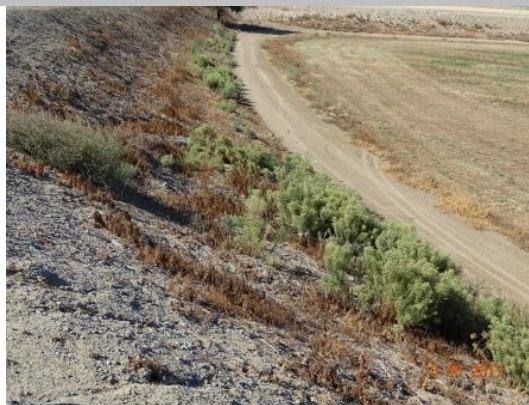
Photo 2 of 2 : SP_2019_RD0001_23_3_20190313_00002.jpg

View of the ruts on the levee slope overgrown with vegetation.
